DOE/NASA/1005-1
NASA TM-83407

Test Results and Description of a 1-kW Free-Piston Stirling Engine with a Dashpot Load

Jeffrey Schreiber
National Aeronautics and Space Administration
Lewis Research Center

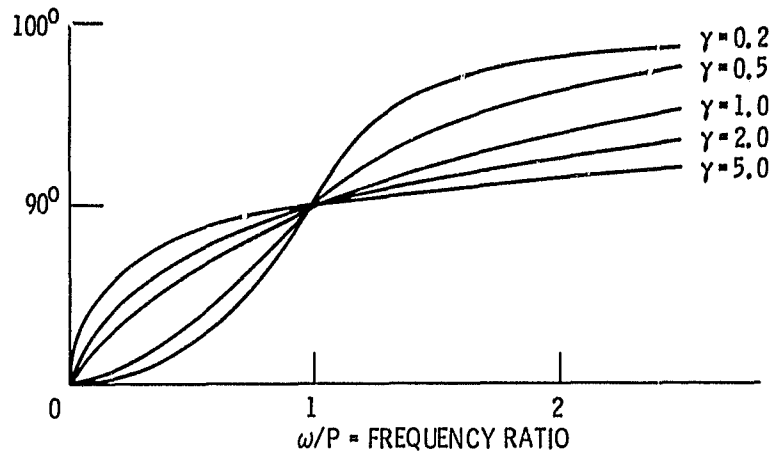
The RE-1000 is designed such that the natural frequency of the displacer is approximately 28 Hz. Since the engine operates at 30 Hz due to the dominant mass of the power piston, the ratio of the driving frequency to the natural frequency of the displacer is $30/28 = 1.07$. It can be seen in Figure 6 that for the case of forced vibration with viscous damping, at a frequency ratio of 1.07, the phase angle between the driving force and the driven response would decrease as the damping increased (Ref. 2) on the RE-1000. However, the phase angle between the power piston and displacer is not the same as the phase angle being shown in Figure 6. This is explained more fully in the following.

With the frequency ratio at 1.07, Figure 6 shows that the phase angle between the driving force and driven response will decrease as the damping increases. This is the same as saying that the phase angle between the power piston and displacer will increase as the damping increases. The remachining of the heat exchanger stack up was intended to reduce the damping by eliminating the slight rub and therefore should reduce the phase angle between the power piston and displacer.

Figure 6. - Relationship of phase angle vs frequency ratio at several damping values.

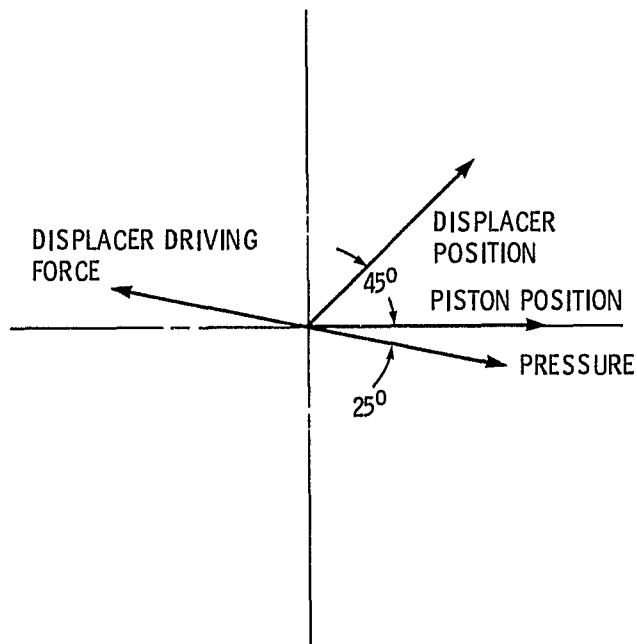
Figure 7 is a phasor diagram of a possible operating point, similar to the design point, for the RE-1000. The phasor diagram is used to show the amplitudes and phase relationships of the different sinusoidal engine parameters. The displacer motion is shown to lead the power piston motion by 45° and the pressure in the compression space lags the piston motion by 25° . Since there is no kinematic linkage in the free piston Stirling engine to drive the displacer, the only forces exerted on the displacer body come from the internal gas spring and the pressure in the working space. To preserve proper sign convention, the driving force on the displacer caused by pressure variations in the working space is along the negative pressure vector. The phase angle between the negative pressure vector and the displacer motion vector is the phase angle represented in Figure 6. It can be shown that this phase angle is 110° .

Figure 7. - Typical RE-1000 phasor diagram operating point.
